# Ford Inova Fairfax Hospital CIREN Team

# A Case Study in Offset Frontal Collision

Vehicle #1: 1998 Chevy Lumina 4door

Vehicle #2: 1999 Honda Civic 2door

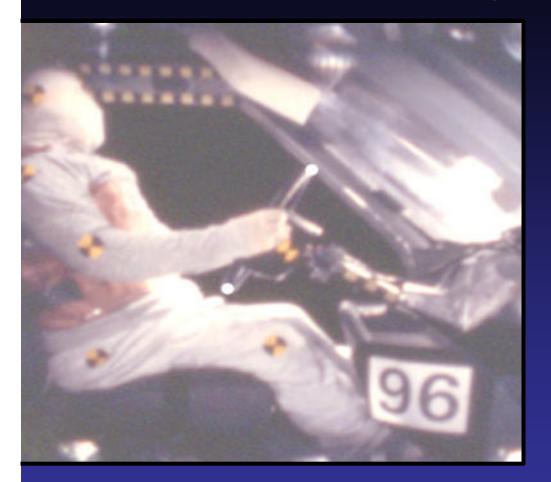
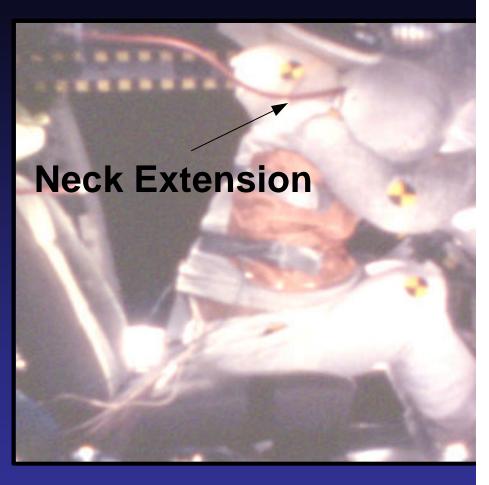
#### Cadaver, unbelted, airbag, 34 km/h frontal pulse

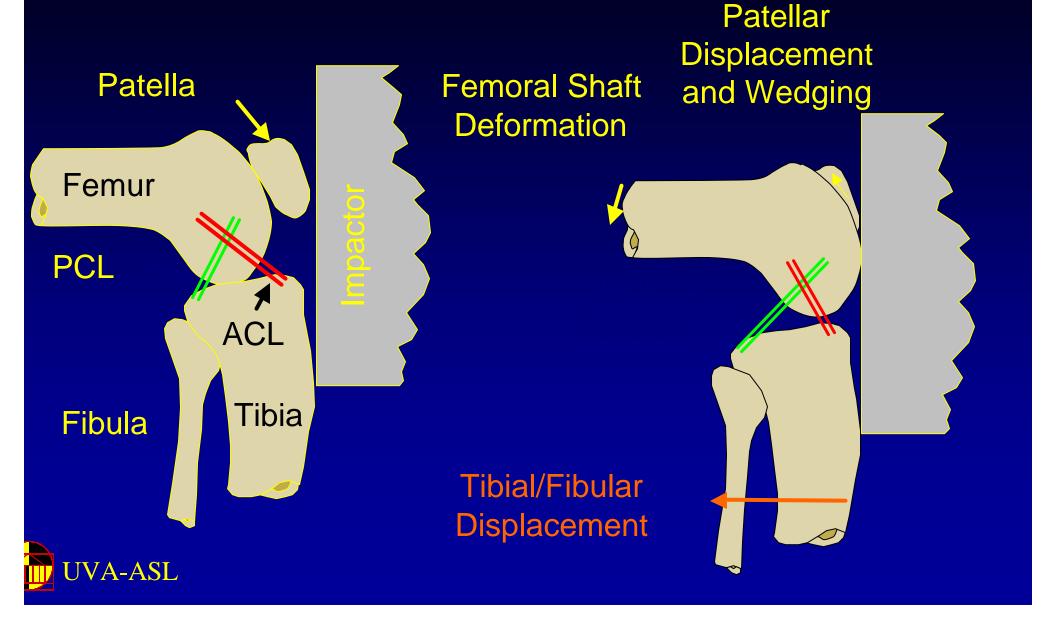
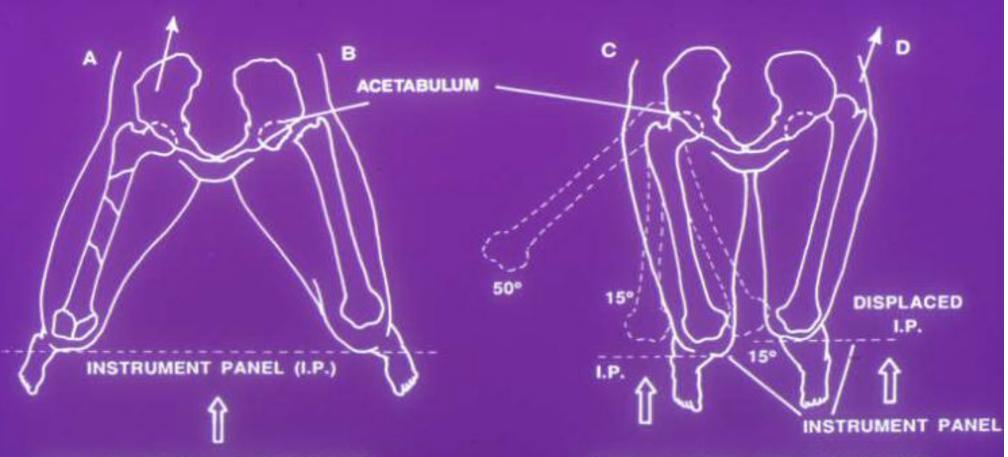
# 90° Knee/Bolster Loading

THIGH FLEXED AND ABDUCTED

FRACTURE OF FEMORAL SHAFT AND/OR CONDYLAR FRACTURES

DISLOCATION OF PROXIMAL FEMUR AND/OR SHEARED HEAD OF FEMUR THIGH FLEXED AND ADDUCTED

C ACETABULAR FRACTURE OR

D POSTERIOR DISLOCATION OF FEMUR
